Proposed Change 1882

Code Reference(s):	NBC20 Div.B 3.8. (first printing)
Subject:	Accessibility, Visitability and Adaptability of Dwelling Units
Title:	Reinforcing Stud Walls in Washrooms for the Future Installation of Grab Bars: Showers and Bathtubs
Description:	This proposed change introduces requirements to reinforce stud walls around showers and bathtubs in dwelling units for the future installation of grab bars.
Related Proposed Change(s):	PCF 1884, PCF 1958, PCF 2030, PCF 2031

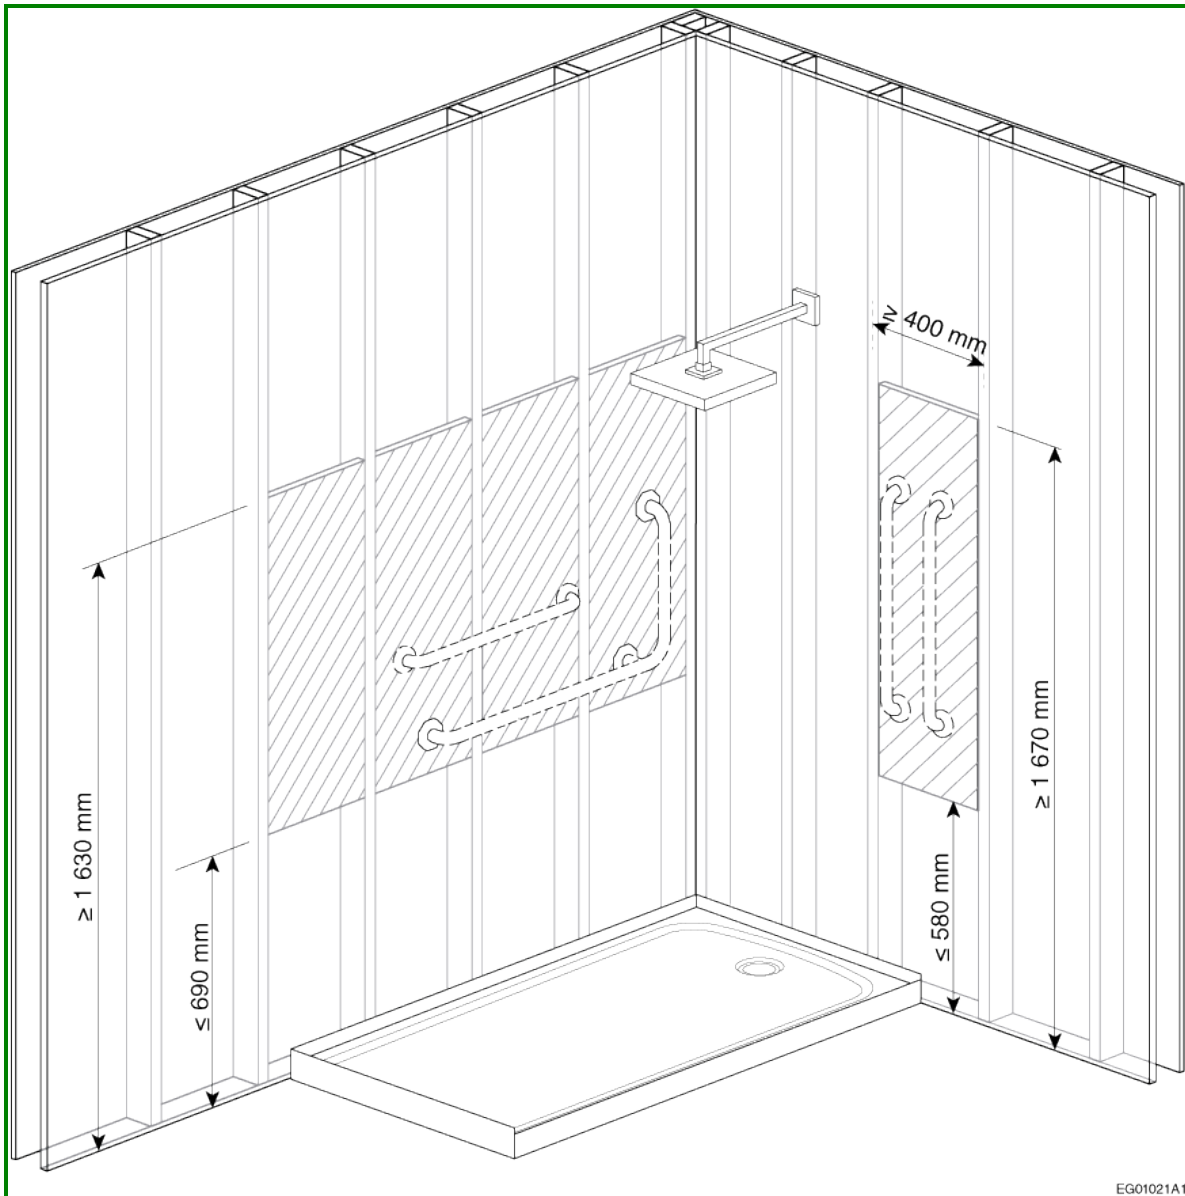
Figure [A-3.8.4.3.(2) and (4)-A]
Example of an acceptable configuration for the reinforcement of the side wall and entrance wall⁽¹⁾ of a shower

Note to Figure :

(1) It is assumed that additional framing (not shown) will be needed to support the reinforcement of the entrance wall; exact stud configurations will depend on factors like the size of the shower and the geometry of the washroom.

Figures 3.8.4.3.(2) and (4)-A and -B illustrate examples of acceptable configurations for the reinforcement of stud walls around showers, bathtubs and bathtub/shower combinations, respectively. Possible grab bar configurations are also shown.

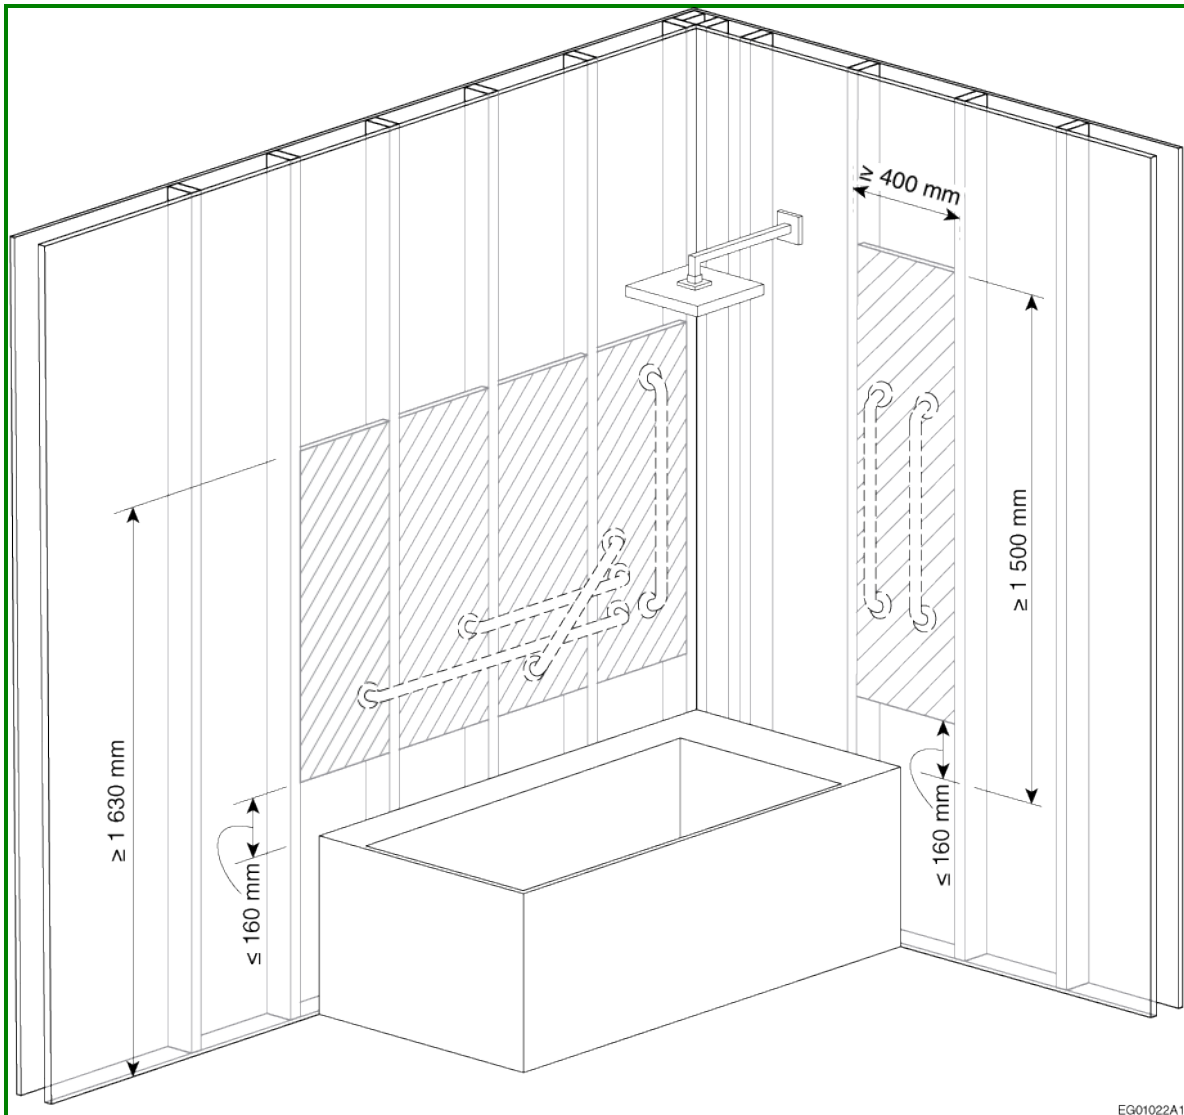
Figure [A-3.8.4.3.(2) and (4)-B]
Example of an acceptable configuration for the reinforcement of the side wall and entrance wall⁽¹⁾ of a bathtub or bathtub/shower combination

Note to Figure :

(1) It is assumed that additional framing (not shown) will be needed to support the reinforcement of the entrance wall; exact stud configurations will depend on factors like the size of the bathtub and the geometry of the washroom.

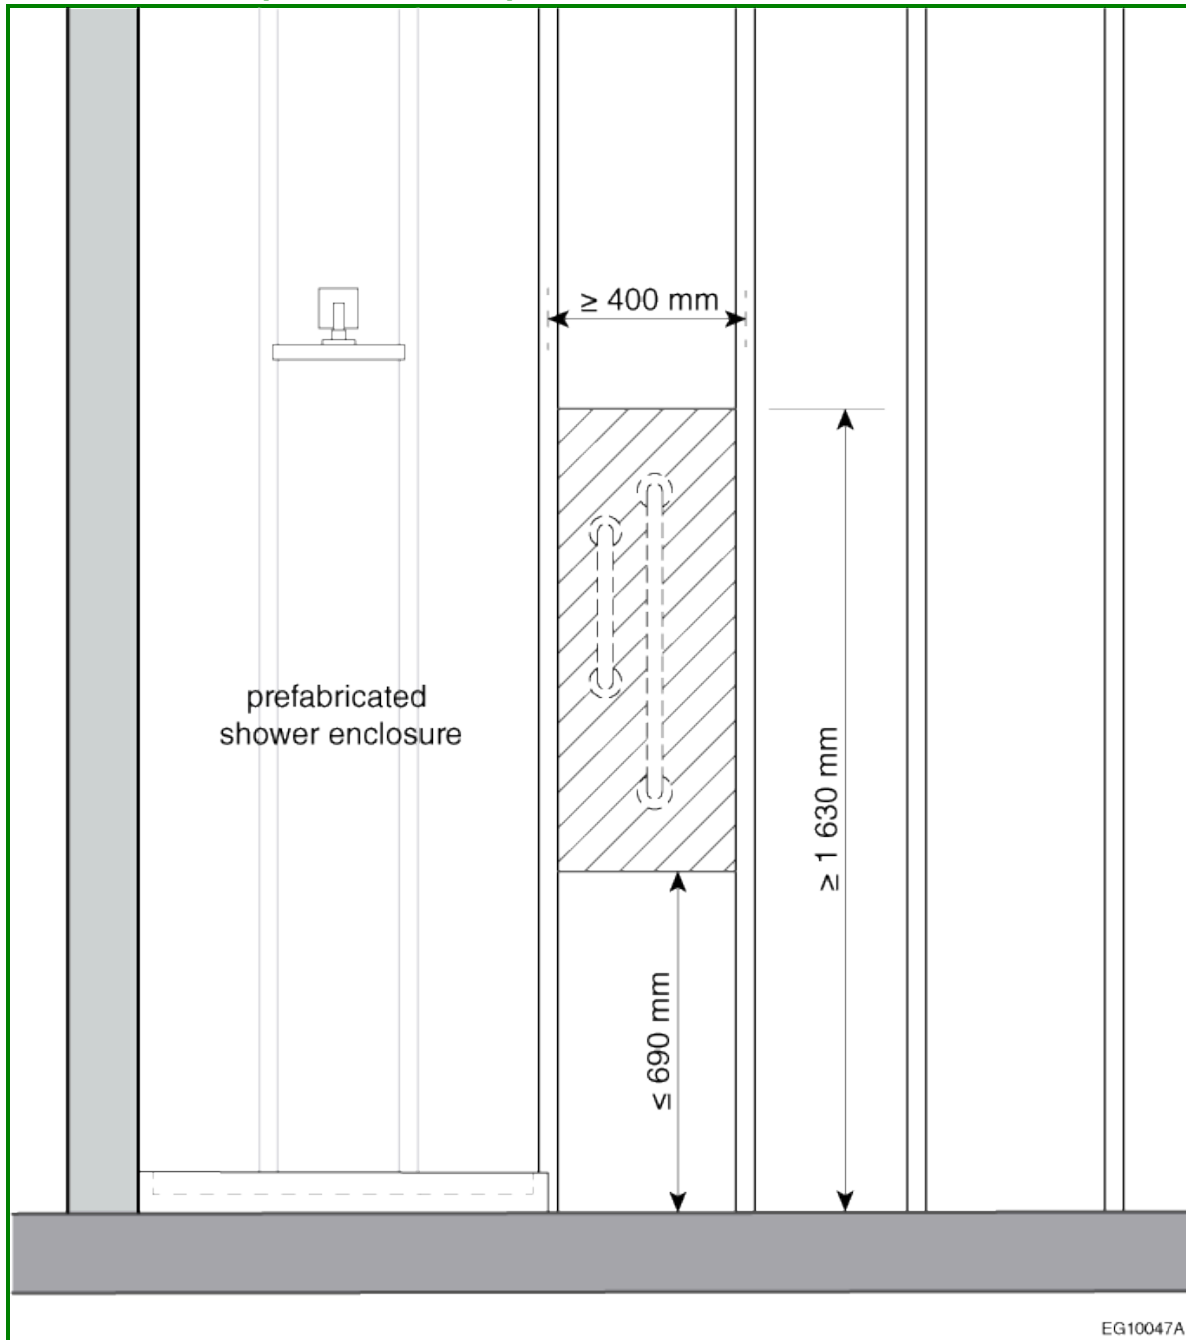
Figure [A-3.8.4.3.(5)-A]
Example of an acceptable configuration for the reinforcement of the entrance wall of a shower provided with a prefabricated enclosure

Showers, bathtubs and bathtub/shower combinations provided with prefabricated enclosures are partially exempted from Sentences 3.8.4.3.(2) and (4), as these enclosures are often not compatible with grab bars that are not fabricated as part of the enclosure. To permit grab bars to be installed near the entrance of these enclosures, the minimum reinforcement area is shifted so that it does not overlap with the prefabricated enclosure. Figures 3.8.4.3.(5)-A and -B illustrate examples of acceptable configurations for the reinforcement of stud walls around prefabricated enclosures. Possible configurations of grab bars with different lengths are also shown.

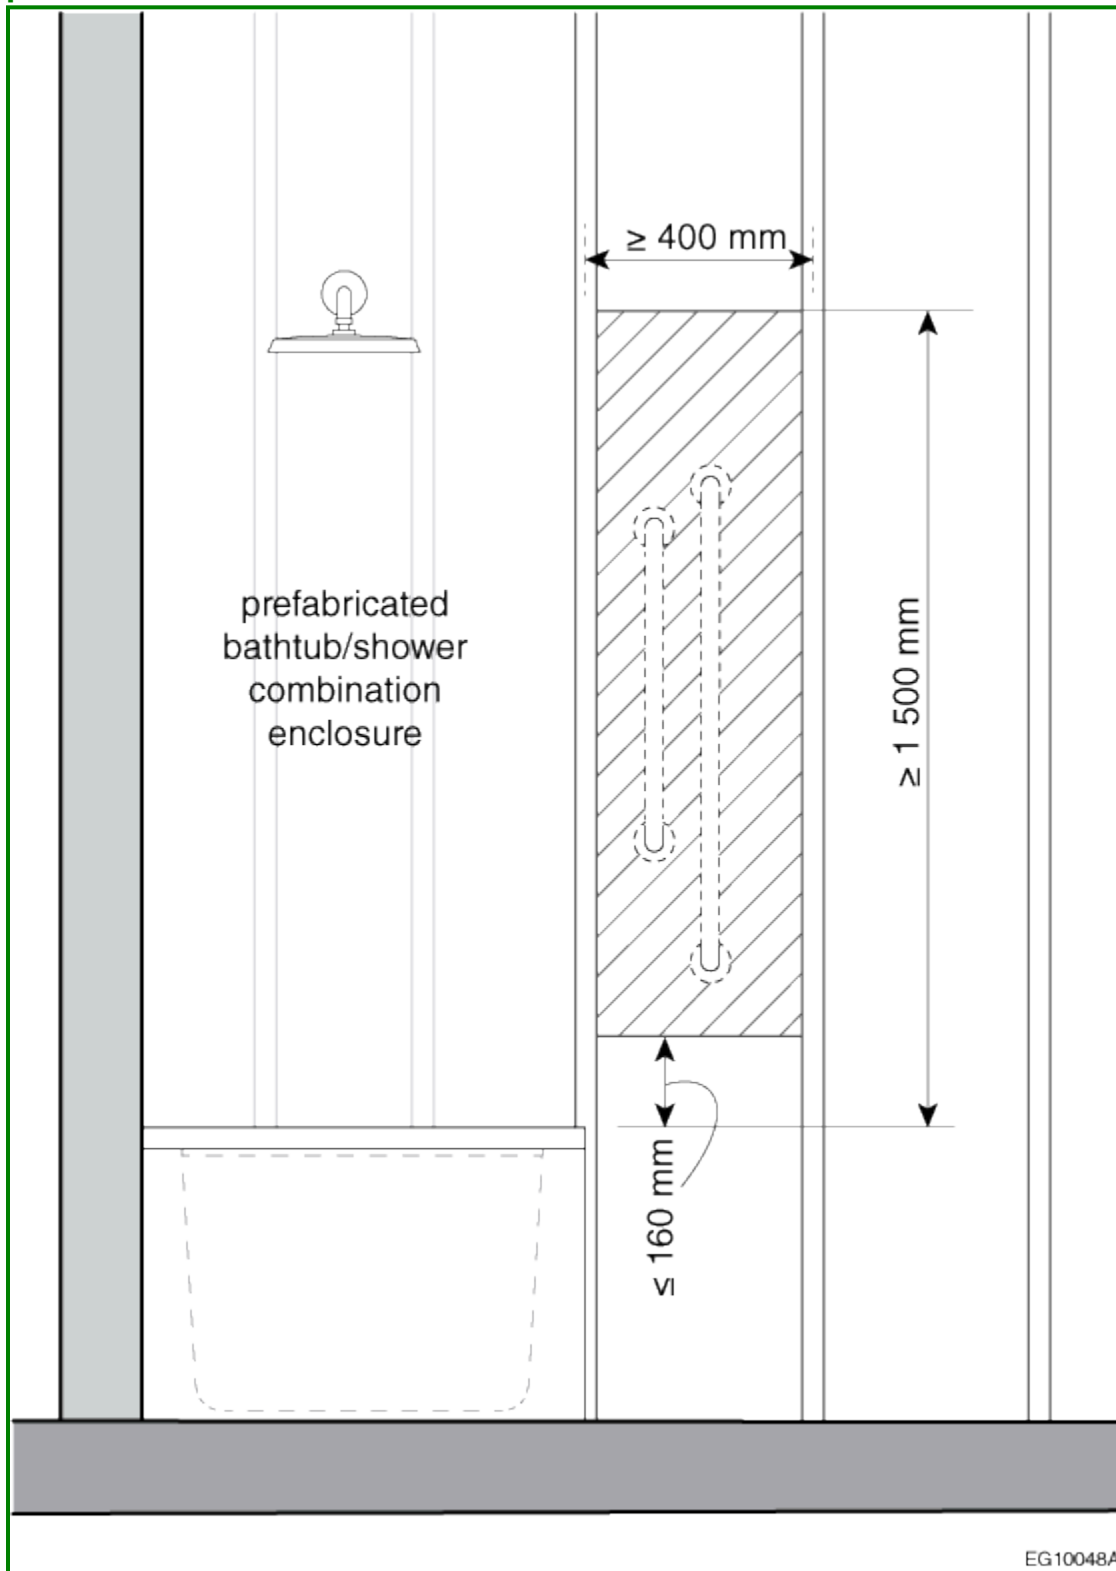
Figure [A-3.8.4.3.(5)-B]
Example of an acceptable configuration for the reinforcement of the entrance wall of a bathtub or bathtub/shower combination provided with a prefabricated enclosure
