Proposed Change 2031

Code Reference(s):	NBC20 Div.B 3.8. (first printing)
Subject:	Accessibility, Visitability and Adaptability of Dwelling Units
Title:	Reinforcing Stud Walls in Washrooms for the Future Installation of Grab Bars: Water Closets
Description:	This proposed change prescribes the reinforcement of walls around water closets in dwelling units for the future installation of grab bars.
Related Proposed Change(s):	PCF 1882, PCF 1884, PCF 1958, PCF 2030

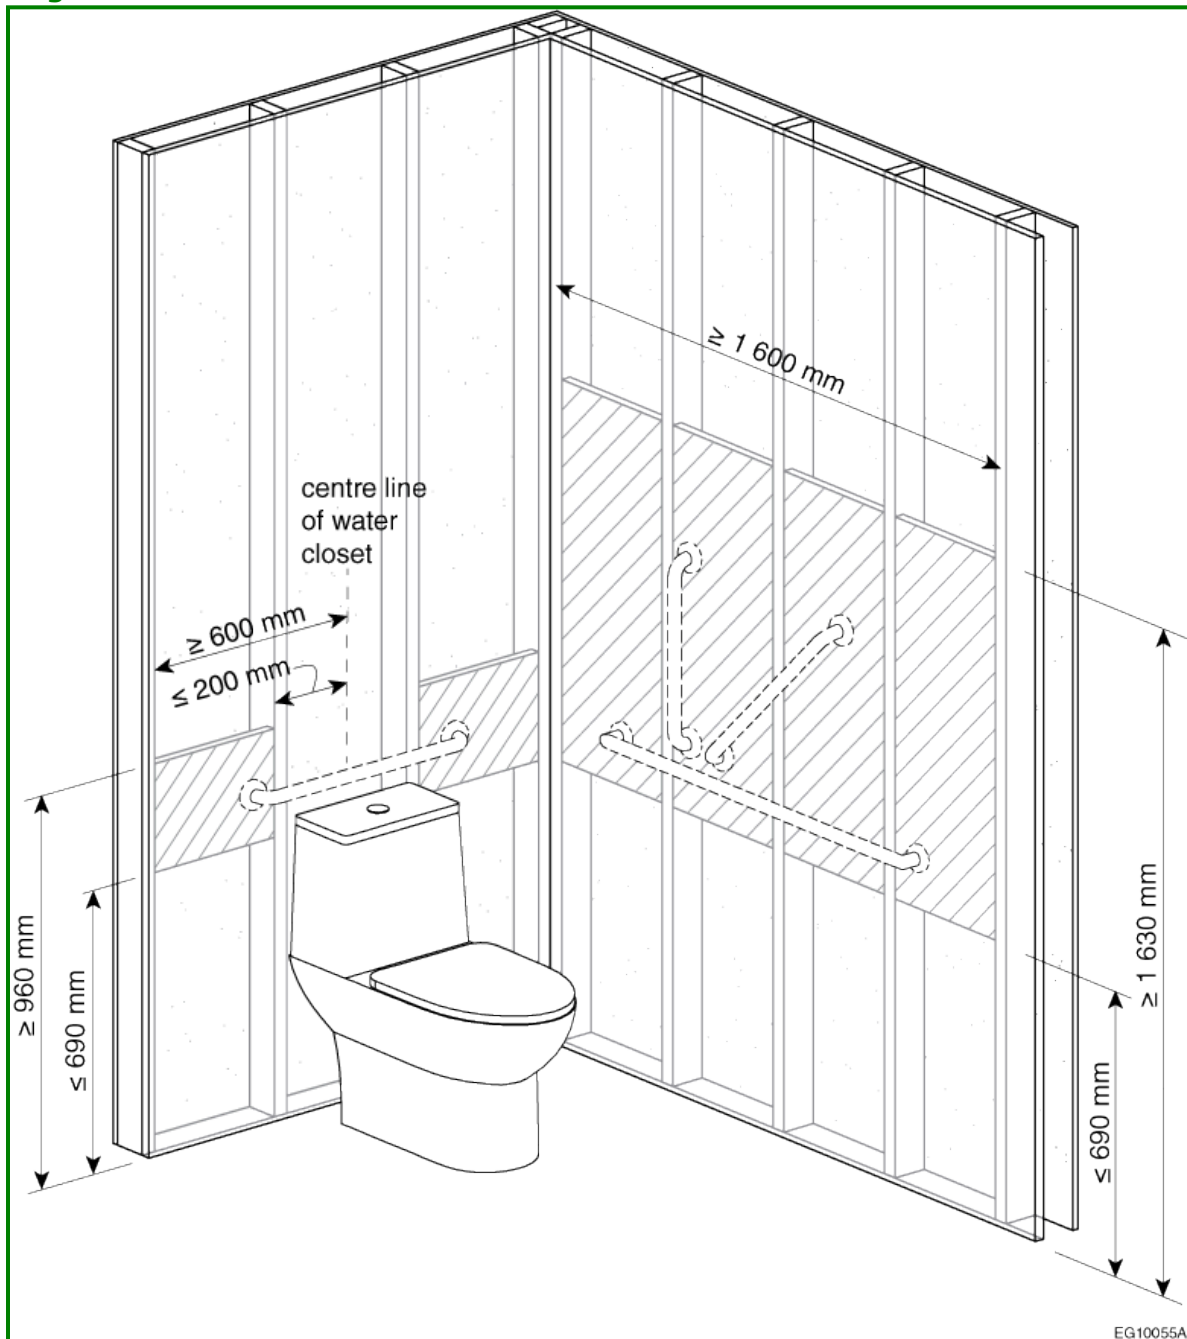
Figure [A-3.8.4.2.(2)]
Example of an acceptable configuration for the reinforcement of stud walls around a water closet, where the horizontal length of the side wall is equal to or greater than 1 600 mm

Figure A-3.8.4.2.(2) illustrates an example of an acceptable configuration for the reinforcement of stud walls around a water closet. Possible grab bar configurations are also shown.
